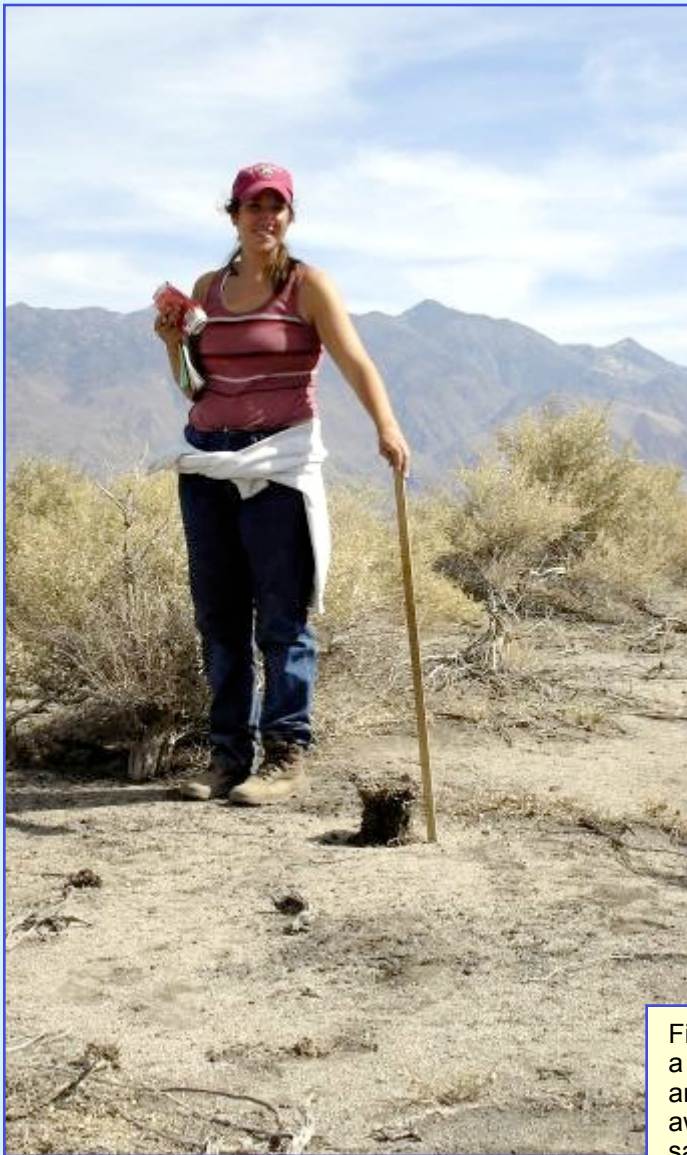
Figure 1. ICWD field assistant Jennifer Hanson (left) stands next to pedestaled remains of a meadow bunchgrass, *Sporobolus airoides*. Remnant roots of the grass still cling to and bind the black, organic soil, even though most of the surrounding soil has eroded away (detail above). The site, south of Independence, converted from meadow to saltbush scrub during the last century primarily due to groundwater pumping. The conversion occurred prior to the Water Agreement, but relics of the past serve to remind how quickly and totally the local environment can change.

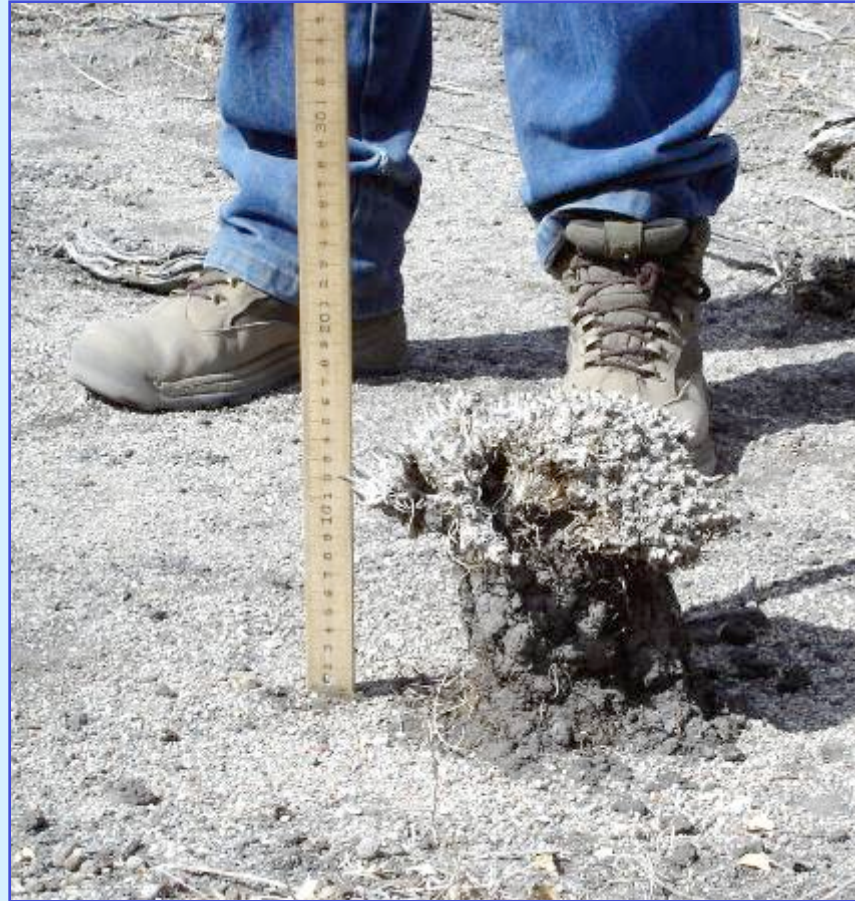
Figure 2. This pedestal sports living sprigs of meadow bunchgrass, *Sporobolus airoides*, in this photo taken in 2007. The site, near Aberdeen, is a somewhat-recovered meadow that suffered the effects of groundwater pumping from about 1987-1997. Water table recovery allowed dormant grasses to resprout, but the local environment experienced soil loss, leaving some living grasses and shrubs on pedestals.
